DOCUMENTATION OF ENVIRONMENTAL INDICATOR DETERMINATION

Environmental Indicator (EI) RCRIS code (CA750)

Migration of Contaminated Groundwater Under Control

Facility Name: Greene, Tweed & Co.

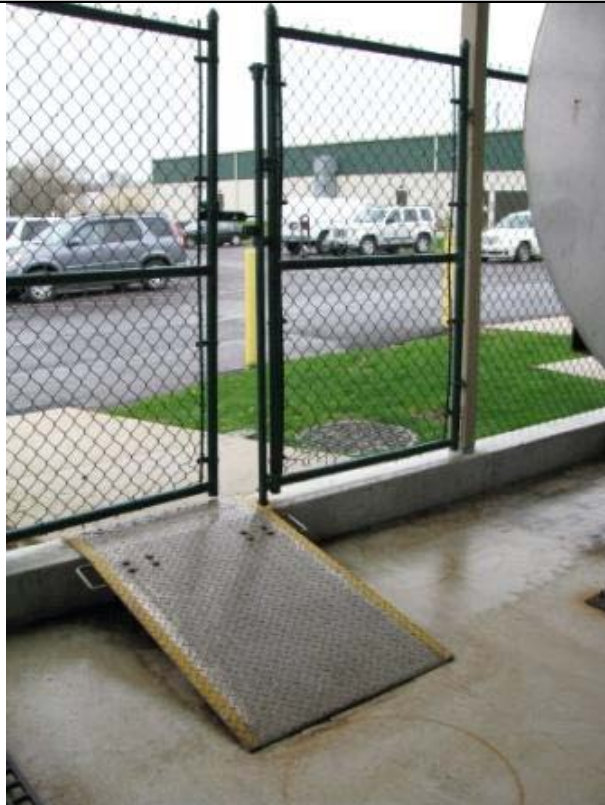
Comments: SWMU 1 - Hazardous Waste Storage Area: Locked/Gated Entrance.

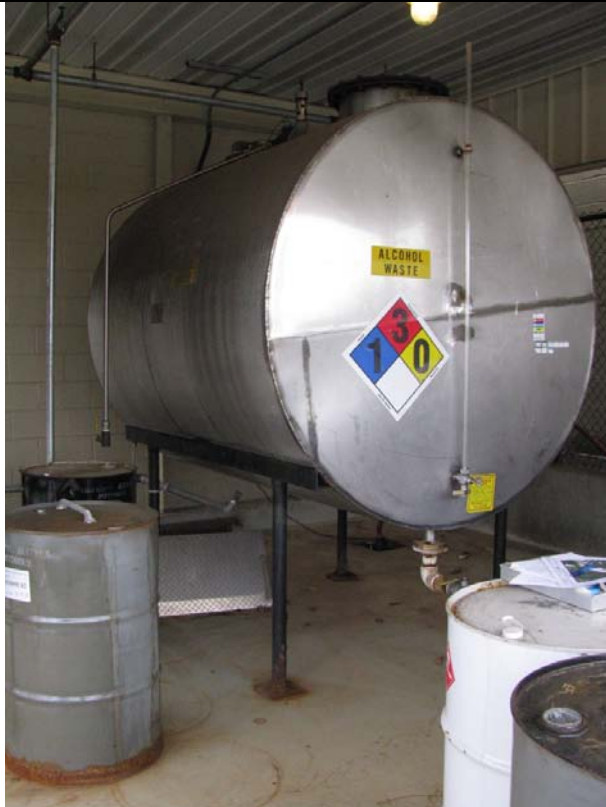
Comments: SWMU 1 – Hazardous Waste Storage Area: Waste Glydex AST.

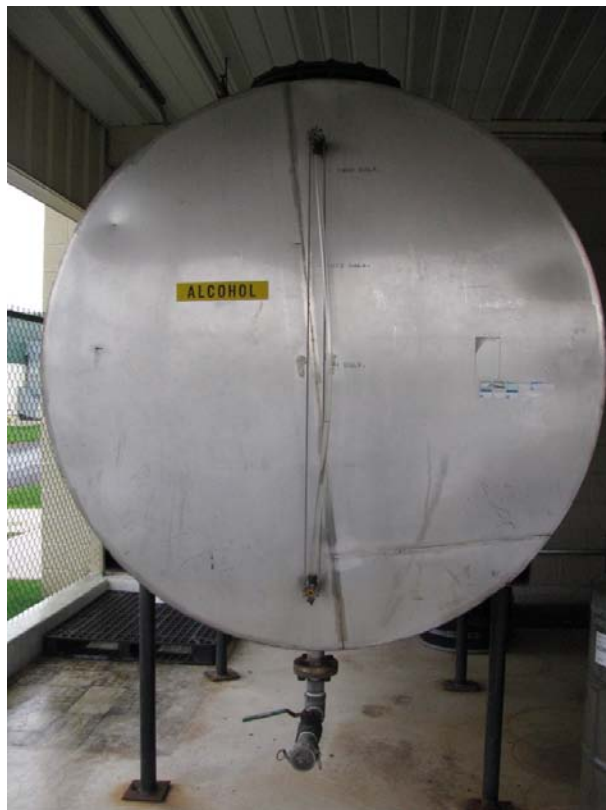
Comments: SWMU 1 – Hazardous Waste Storage Area: Virgin Isopropanol AST.

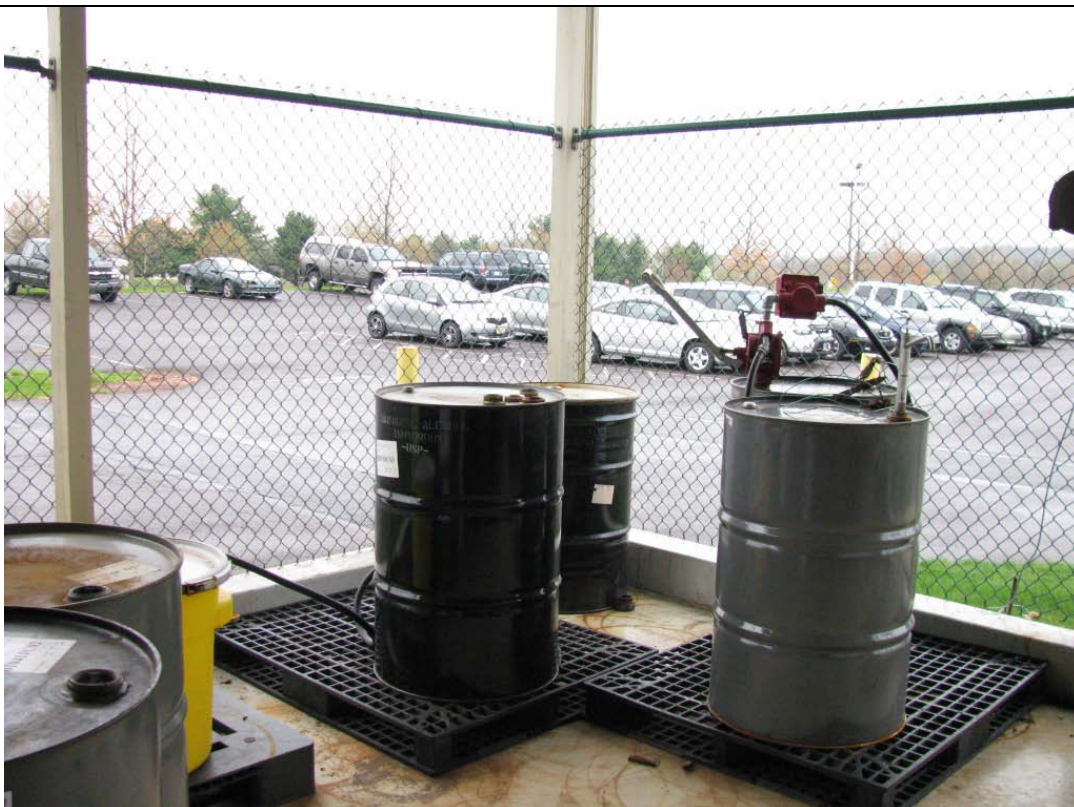
Comments: SWMU 1 – Hazardous Waste Storage Area: Drummed Virgin/Waste Isopropanol Storage.

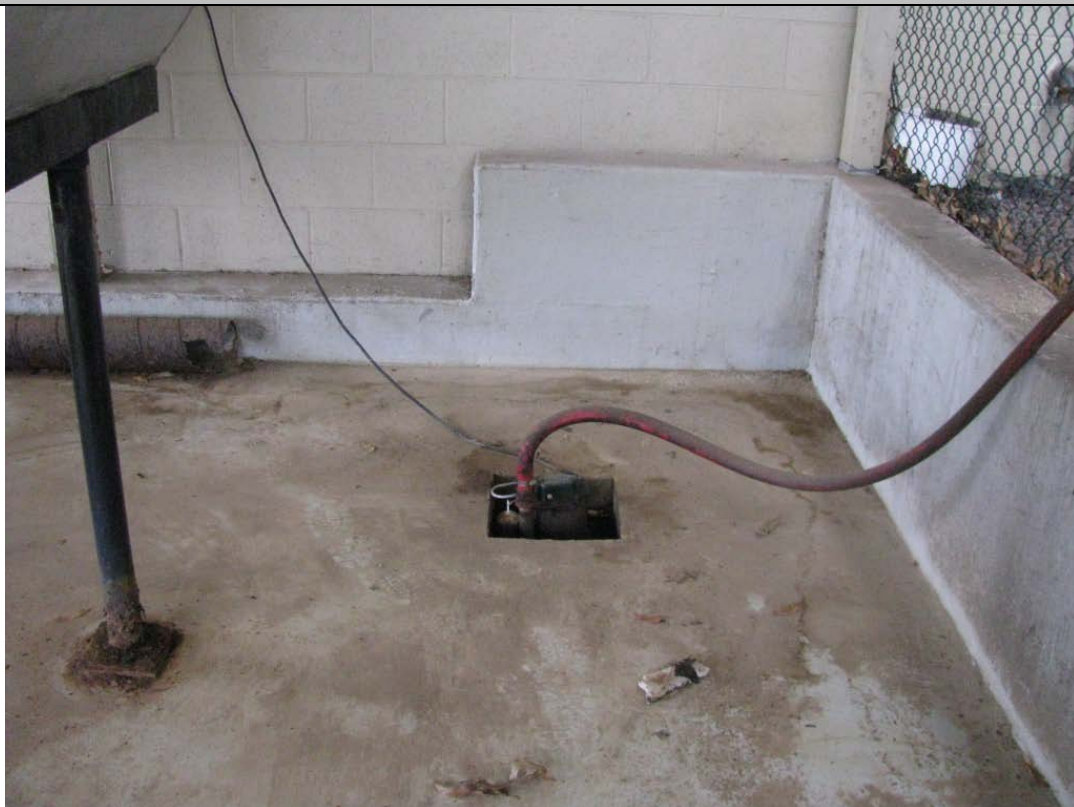
Comments: SWMU 1 – Hazardous Waste Storage Area: Self-contained Concrete-lined Sump.

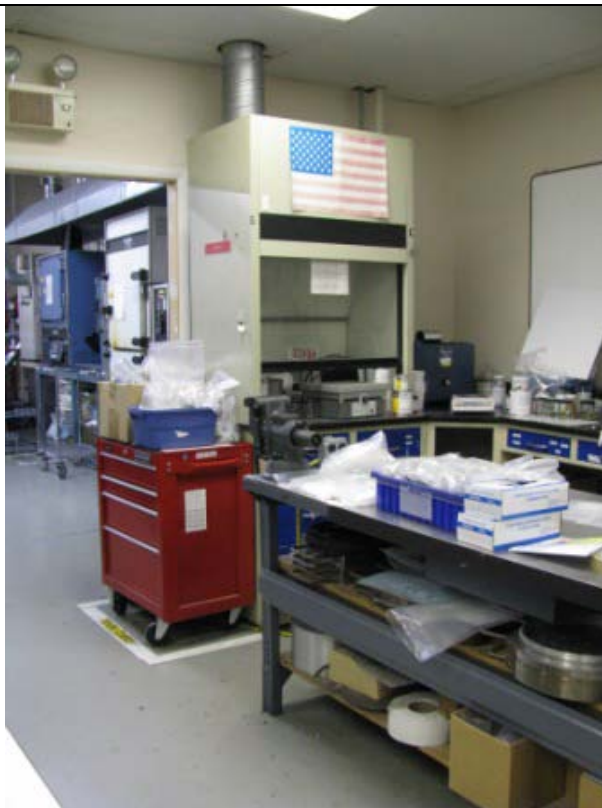
Comments: Former location of SWMU 2 – Methylene Chloride Waste Drum in the Former Urethane Production Area.

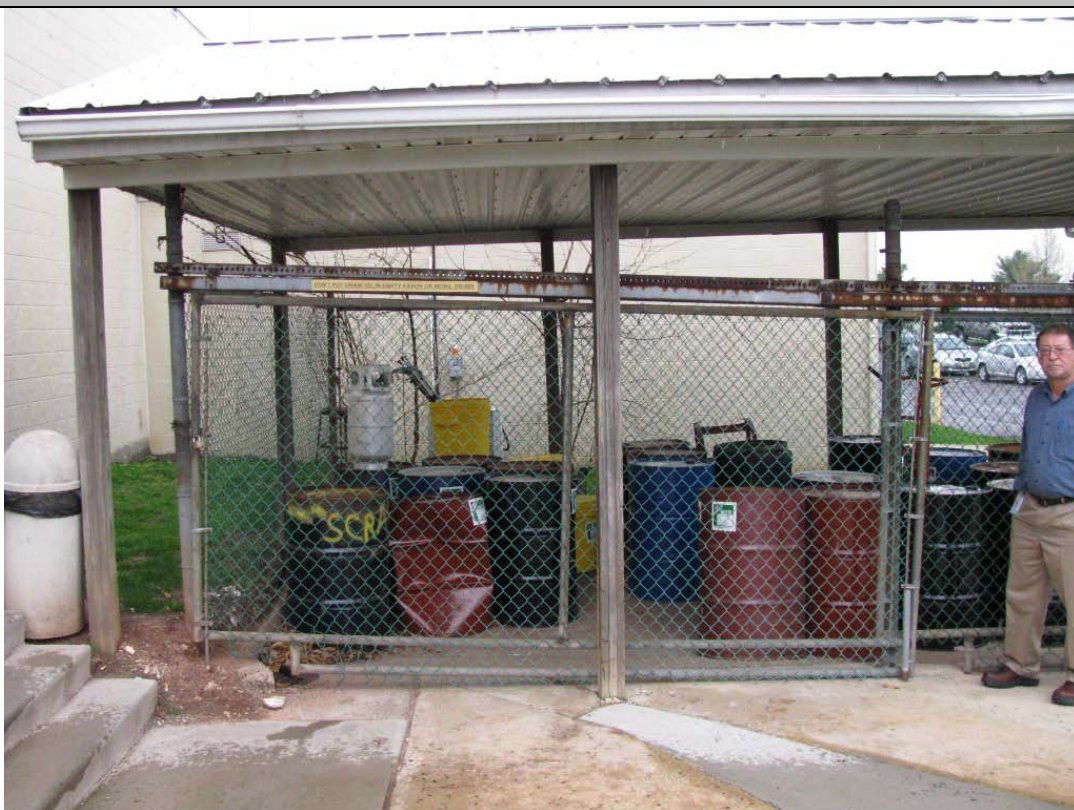
Waste hydraulic oil and coolant are stored in the covered, open-sided storage area located east of the current hazardous waste storage area (SWMU 3). These wastes are managed as residual wastes by the facility. The storage area consists of a 20 foot by 20 foot concrete pad that is surrounded on the northeast, northwest, and southwest sides by a six-foot high concrete curb. There is no curb on the southeast side of the storage area. The concrete outside the storage area has been recently patched (there are joints in the surface). The curb on the northwest and southwest sides is level with the grass surface. A small grass area is located directly outside of the northeast corner. The concrete pad is sloped toward the northwest corner. A small amount of precipitation was observed pooled in this corner. The storage area is surrounded by a six-foot high chain link fence that is gated and locked. The 55-gallon drums are stored directly on the concrete pad. At the time of the site visit, 23 drums of waste hydraulic oil and coolant were stored in this area. The majority of the drums were in good condition; however, at least one drum was significantly dented. There appeared to be no evidence of spills on the observable portions of the concrete pad, and the surrounding vegetation appeared healthy.

Comments: AOC 1 – Waste Hydraulic Oil/Coolant Storage Area.

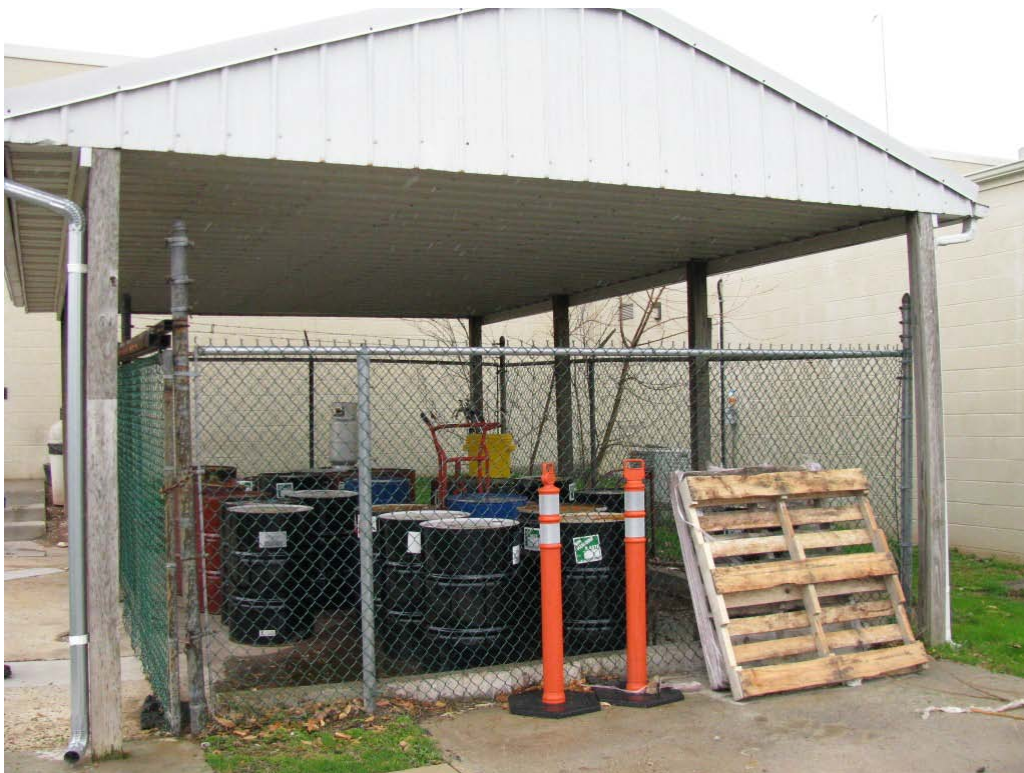
Comments: AOC 1 – Waste Hydraulic Oil/Coolant Storage Area.

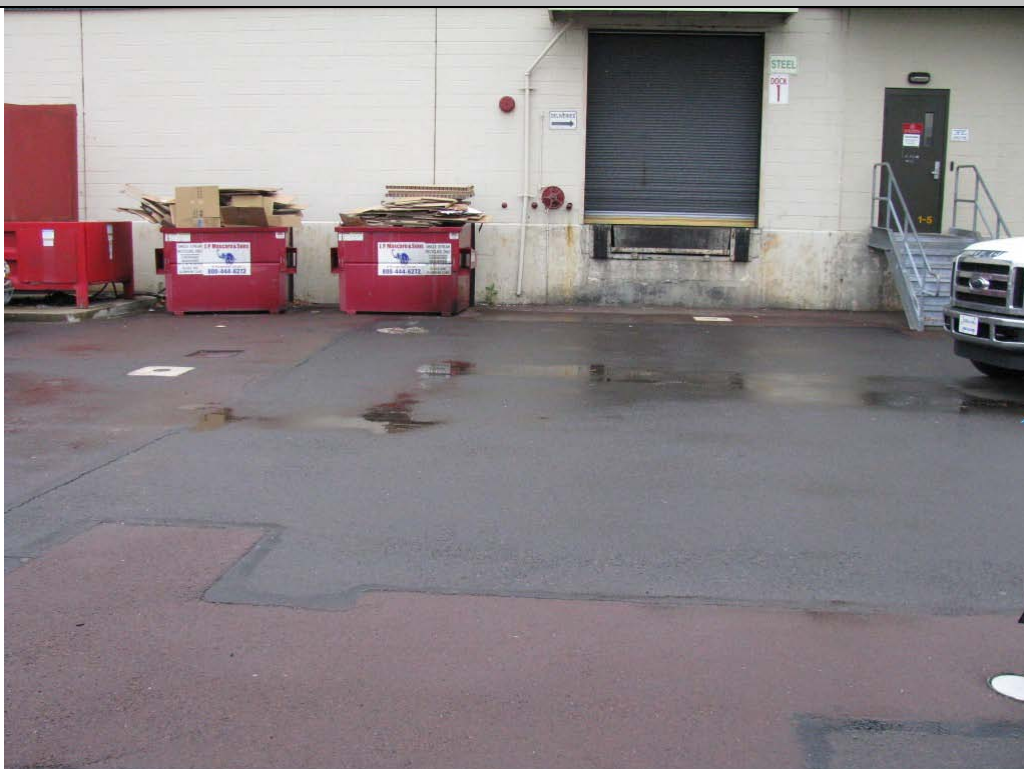
According to the PA (NUS, 1989), the 20,000-gallon UST containing No. 6 fuel oil (UST 001) was discovered to have leaked. PADEP inspection reports dated May 20, 1983; May 25, 1983; May 26, 1983; May 27, 1983; June 8, 1983; July 11, 1983; September 1, 1983; and April 2, 1984 indicate that the facility notified PADEP of the release in May 1983. Oil-saturated soil was observed in the excavation during removal of the UST and approximately one inch of oil was observed on water entering the excavation. In addition, No. 6 fuel oil was observed in the drainage swale located behind the facility. It was believed that the oil was migrating along underground utility lines to the drainage swale. The facility installed oil/water separators. The contents were vacuum pumped regularly. On September 27, 1983, the facility notified PADEP that 1,450 gallons of No. 6 fuel oil was recovered.

Comments: Location of 1983 Leaking No. 6 Fuel Oil UST and 2002 Act 2 No. 6 Fuel Oil Release – Tank Area.

PADEP conducted an inspection on February 11, 2002 and sent the facility guidance to properly close the USTs and achieve compliance with the Clean Streams Law. The two USTs were removed between February 23 and 26, 2002. Impacted soil and free product were observed around the former UST locations. The impacted soil extended to weathered bedrock which was encountered at approximately five feet bgs within the excavation. Impacted material was removed from the excavation and properly disposed. Free product was observed on the surface of perched water within the excavation. To remove free product on the shallow groundwater surface within the excavation, several enhanced fluid recovery (EFR) pump outs of groundwater within the open excavation were conducted. Between EFR events, oil-only absorbent booms and pads were placed in the excavation to recover any product entering the excavation. The EFR events and placement and maintenance of oil absorbent pads and booms were continued until no free product was observed and the sheen on the groundwater surface was eliminated. The UST tank remedial activities were performed in accordance with Act 2.

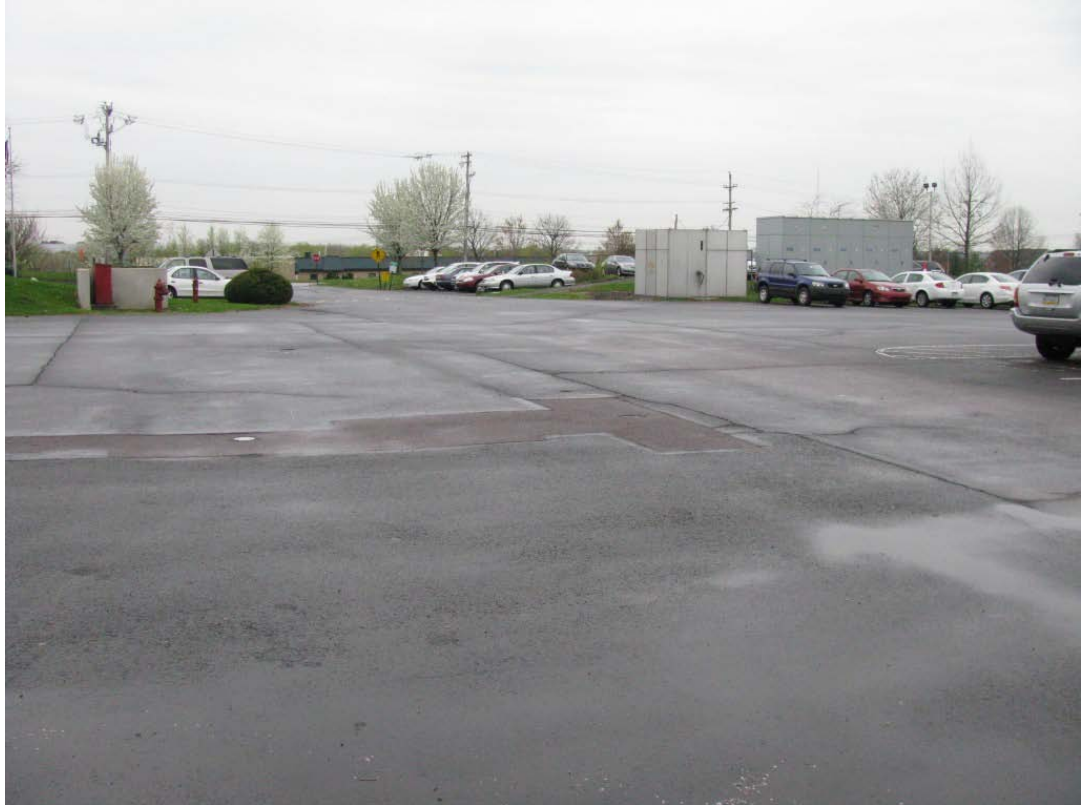
Comments: Location of 1983 Leaking No. 6 Fuel Oil UST and 2002 Act 2 No. 6 Fuel Oil Release – Tank Area.

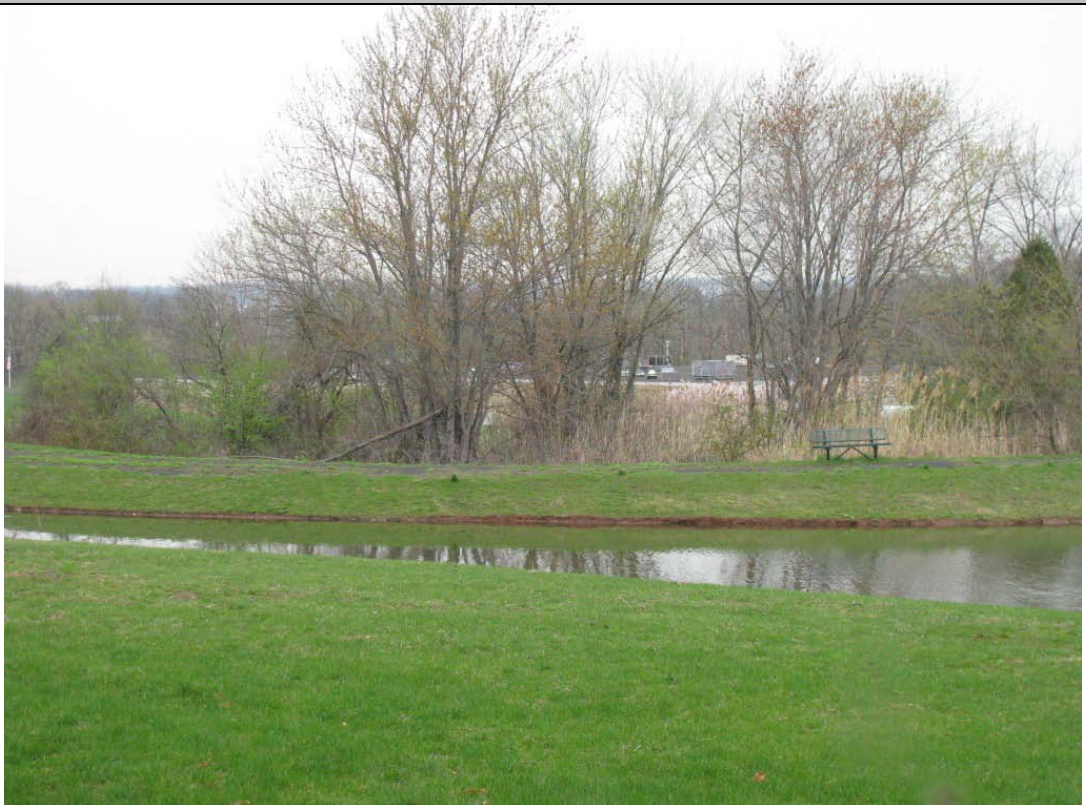
On February 8, 2002, PADEP received an incident notification for a large release impacting Skippack Creek (later determined to be 200 gallons of No. 6 fuel oil) following a refueling event at the facility. The leak reportedly originated from the 20,000 gallon UST containing No. 2 fuel oil (UST 001) and the 15,000 gallon UST containing No. 4 fuel oil (UST 002). (Note: Through its operational history, the facility varied heating oils stored in each UST. These are the same USTs that were the focus of the 1983 release.) The 200 gallons of released oil migrated across the asphalt parking lot, into a stormwater drainage pipe, and into a drainage swale located on the north end of the facility. An estimated 50 gallons of

Comments: Location of 2002 Act 2 No. 6 Fuel Oil Release – Drainage Swale Area.
